Qualification of Surface Preparation Processes for Bonded Aircraft Repair

R. Giles. Dillingham
BTG Labs
5129 Kieley Place
Cincinnati, OH 45217

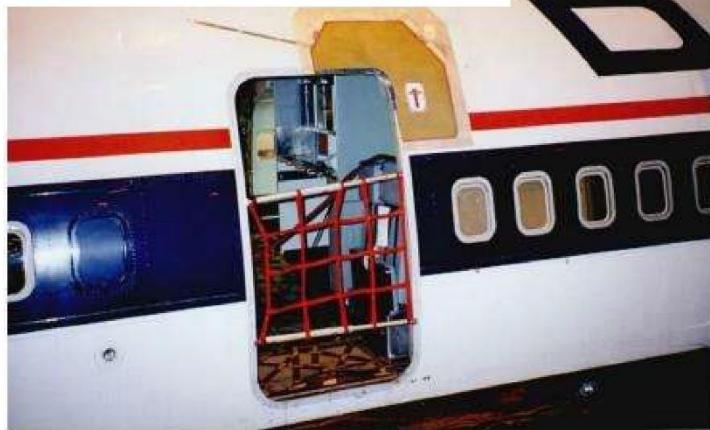
Figure 1. Bonded boron/epoxy composite doubler for repair of aluminum aircraft [1].
